CONTRACTOR REPORT ARLCD-CR-84001

ON-SITE SURVEY AND ANALYSIS OF PYROTECHNIC MIXER BAYS

DAVE KOSOVER
NORVAL DOBBS
AMMANN & WHITNEY, CONSULTING ENGINEERS
TWO WORLD TRADE CENTER
NEW YORK, NY 10048

FEBRUARY 1984

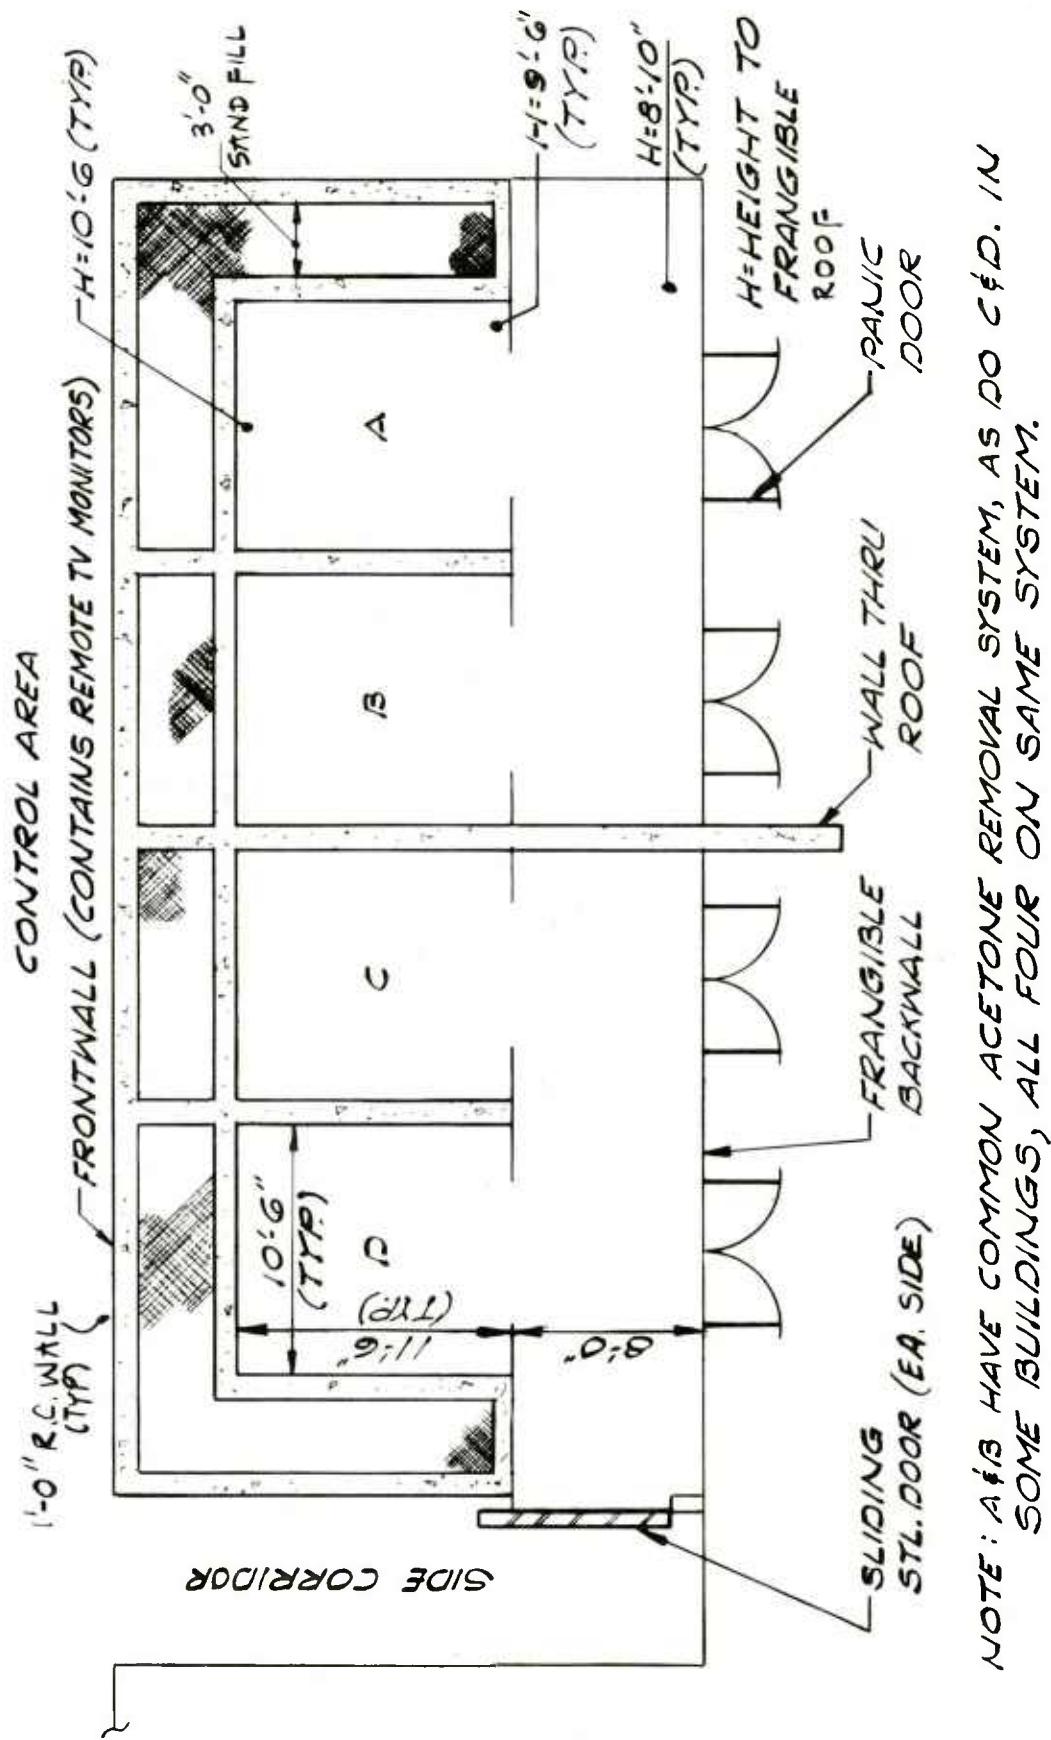
In the bay configuration for Buildings 7 through 16, an avenue of direct propagation through fireball or vapor ignition exists in the corridor connecting Bays A and B or C and D. In the case of Building B-11, propagation may occur through the interconnected exhaust system via vapor ignition (Figure 6)

In the bays of Building 7 through 16, the sliding steel door may not adequately resist blast pressures. However, if these doors are of adequate strength to resist blast pressures, they may not be sufficiently sealed to prevent fireball leakage. If leakage occurs through these steel doors, the fireball may travel up the side corridors into the main corridor or control area.

Figure 1 Plan of bays, Buildings 7 through 16, Longhorn AAP

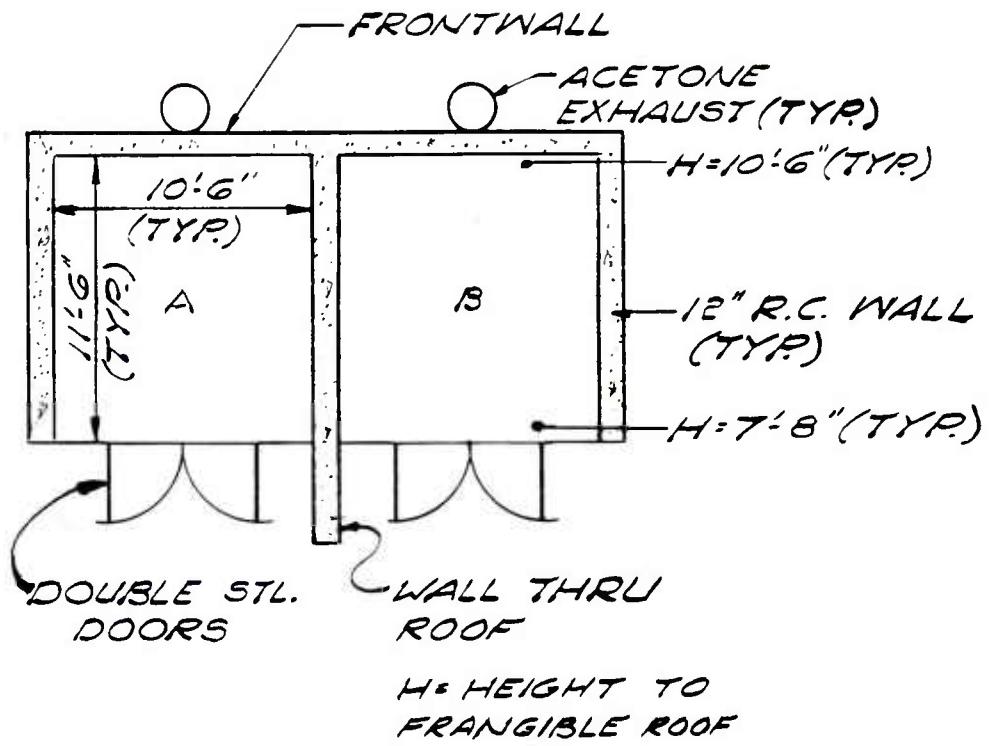
In the bay configuration shown in the sketch of Building 212-33 (Figure 7), each bay is partitioned and direct propagation is negated. Each bay has an individual acetone exhaust system.

Figure 2 Plan of Building 212-33, Longhorn AAP

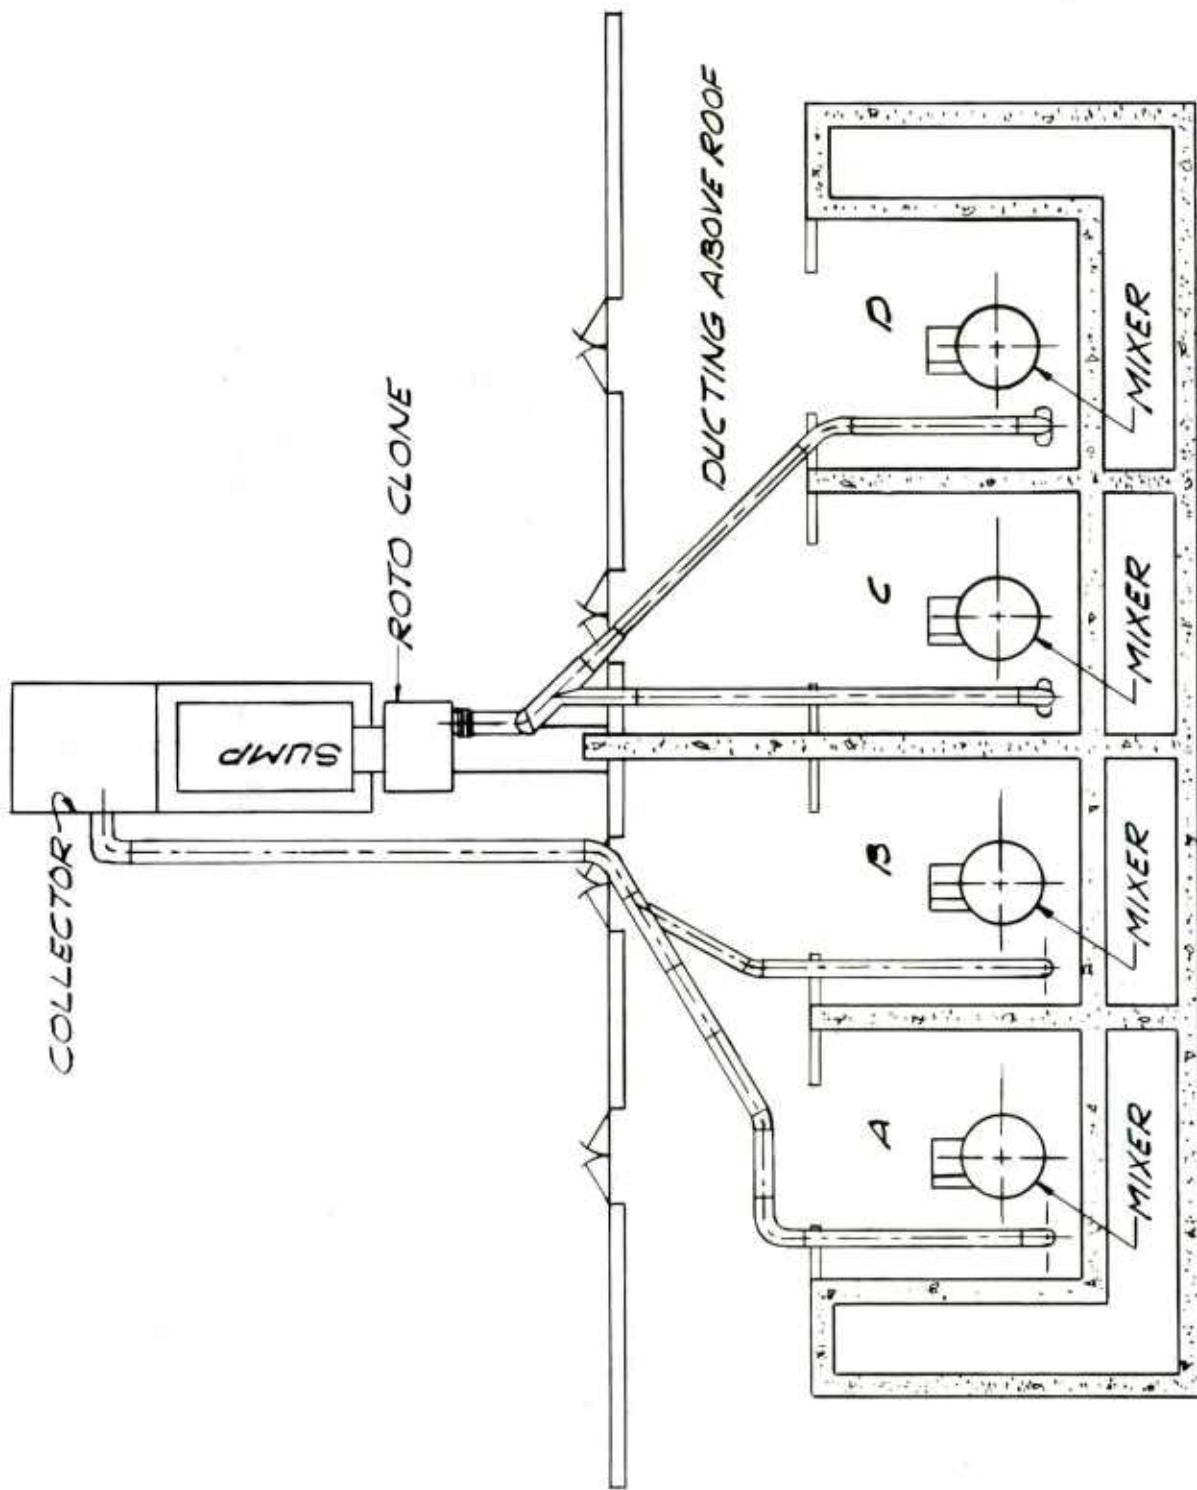
Figure 6 Partial Plan of Building B-II showing interconnecting ductwork, Longhorn AAP

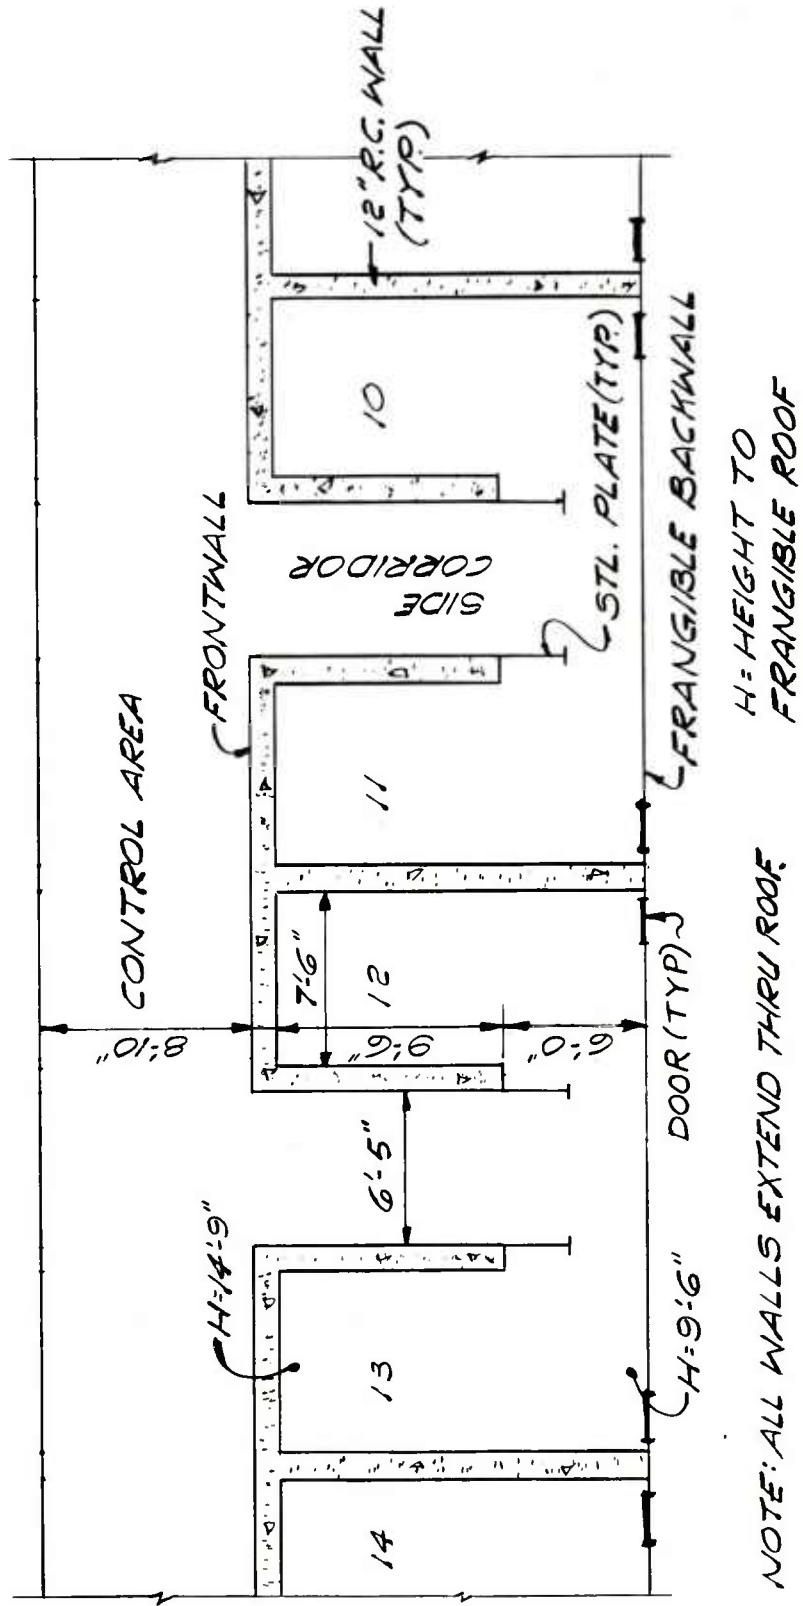
It can be seen, from the bay configuration of Building G-33, propagation may occur from one bay to the side corridor and/or to the adjacent bay. In building G-11, propagation can occur down the side corridor into the area of the support bays.

If the viewports, which are located at the frontwall of each bay of Building G-33, are not of sufficient strength to resist the blast pressures, then these pressures will flow into the control area.

Figure 8 Partial Plan of Building G-33, Lonestar AAP

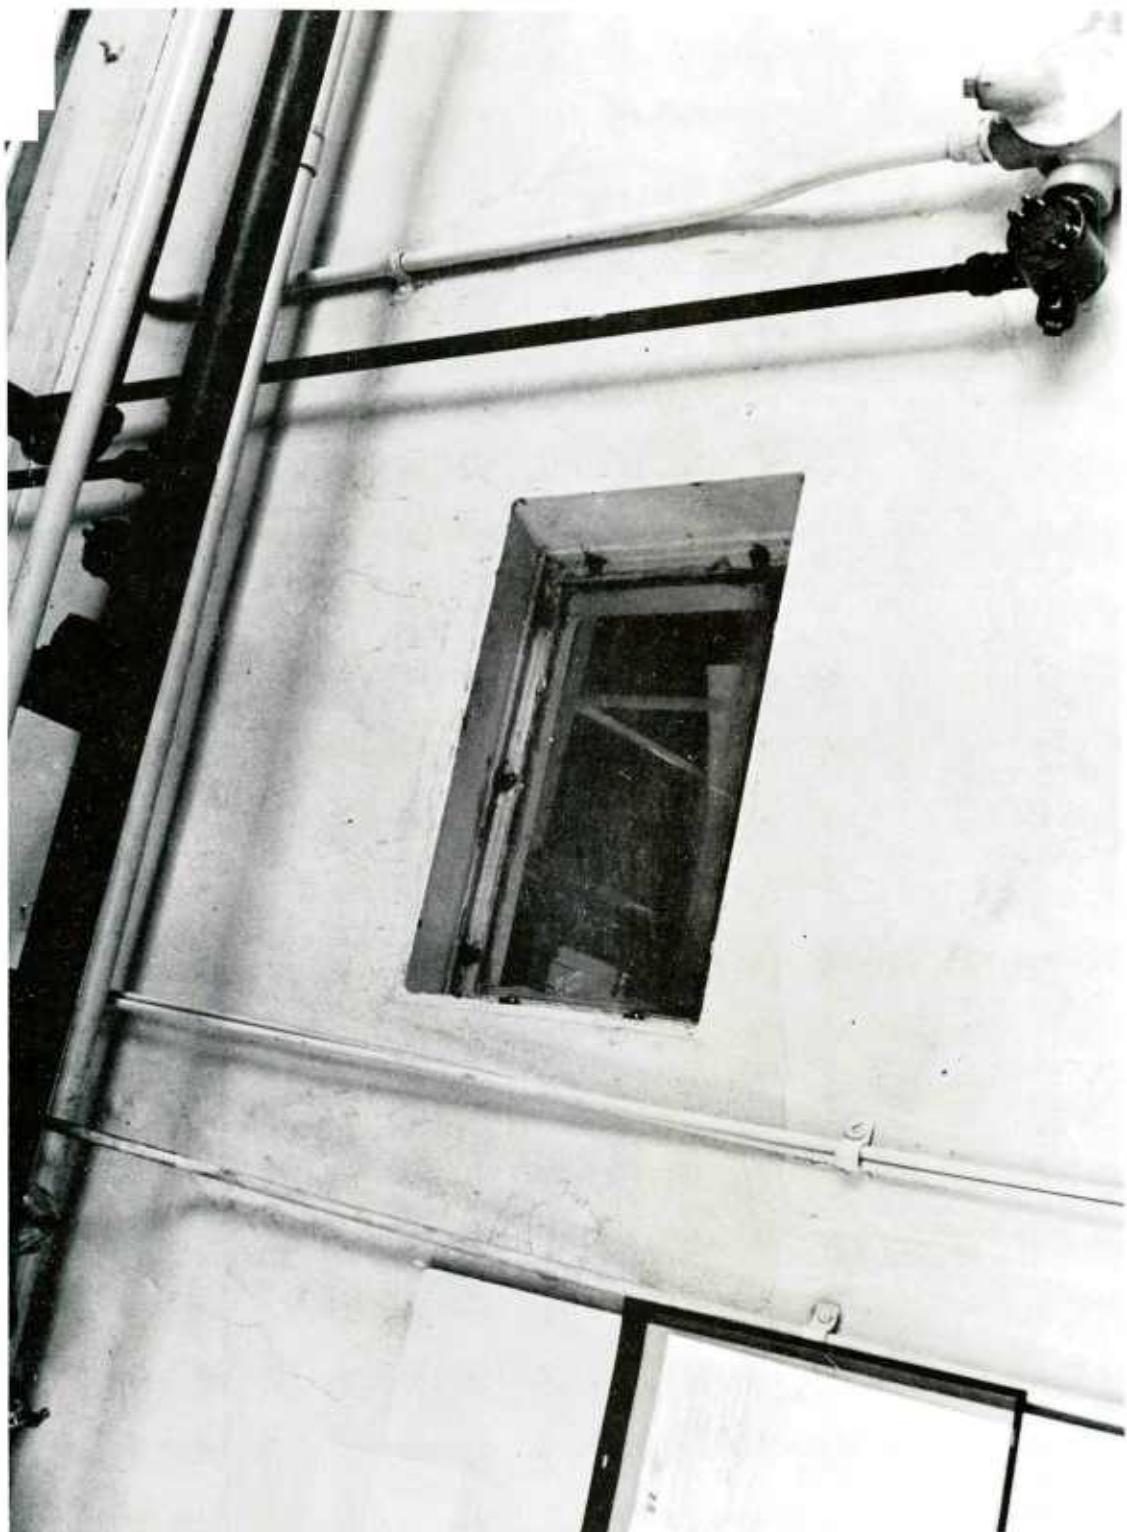
Figure 10 Viewport at frontwall of bay, Lonestar AAP

Extensive propagation may occur into the control area if the steel plate doors or their supporting hinges are not of adequate strength. In addition, the viewports on each door may fail under elevated pressures even if the doors are strong enough to survive the blast pressures.

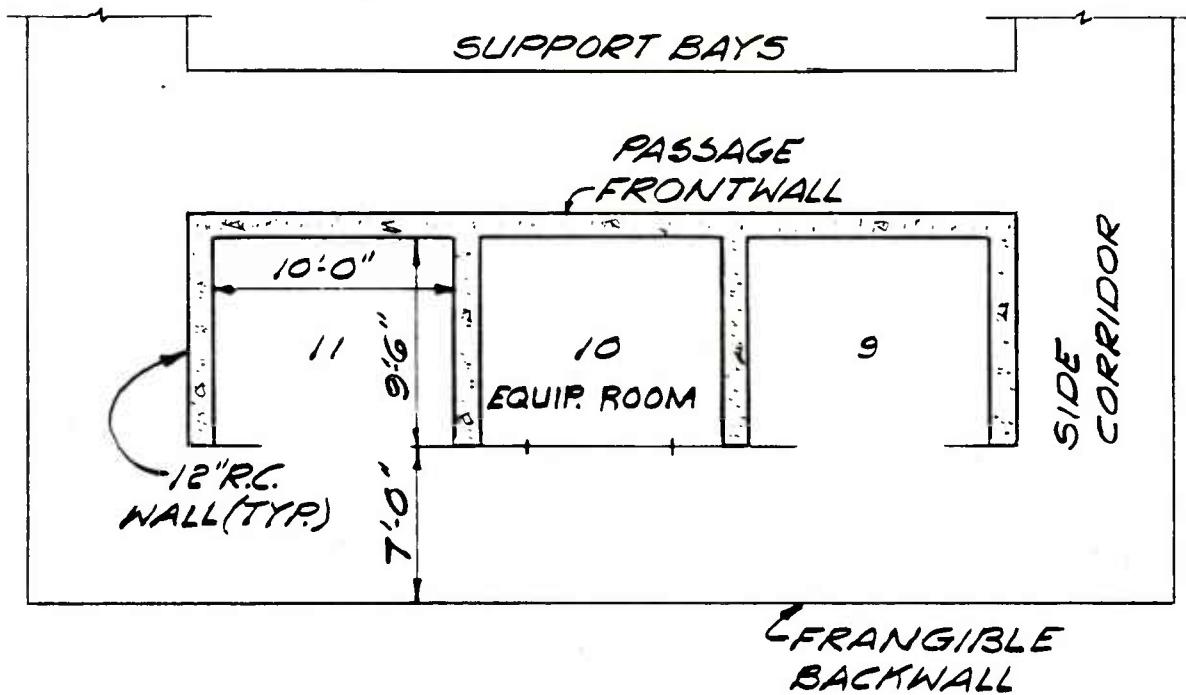
Figure 11 Partial Plan of mixing bays, Building G-11, Lonestar AAP

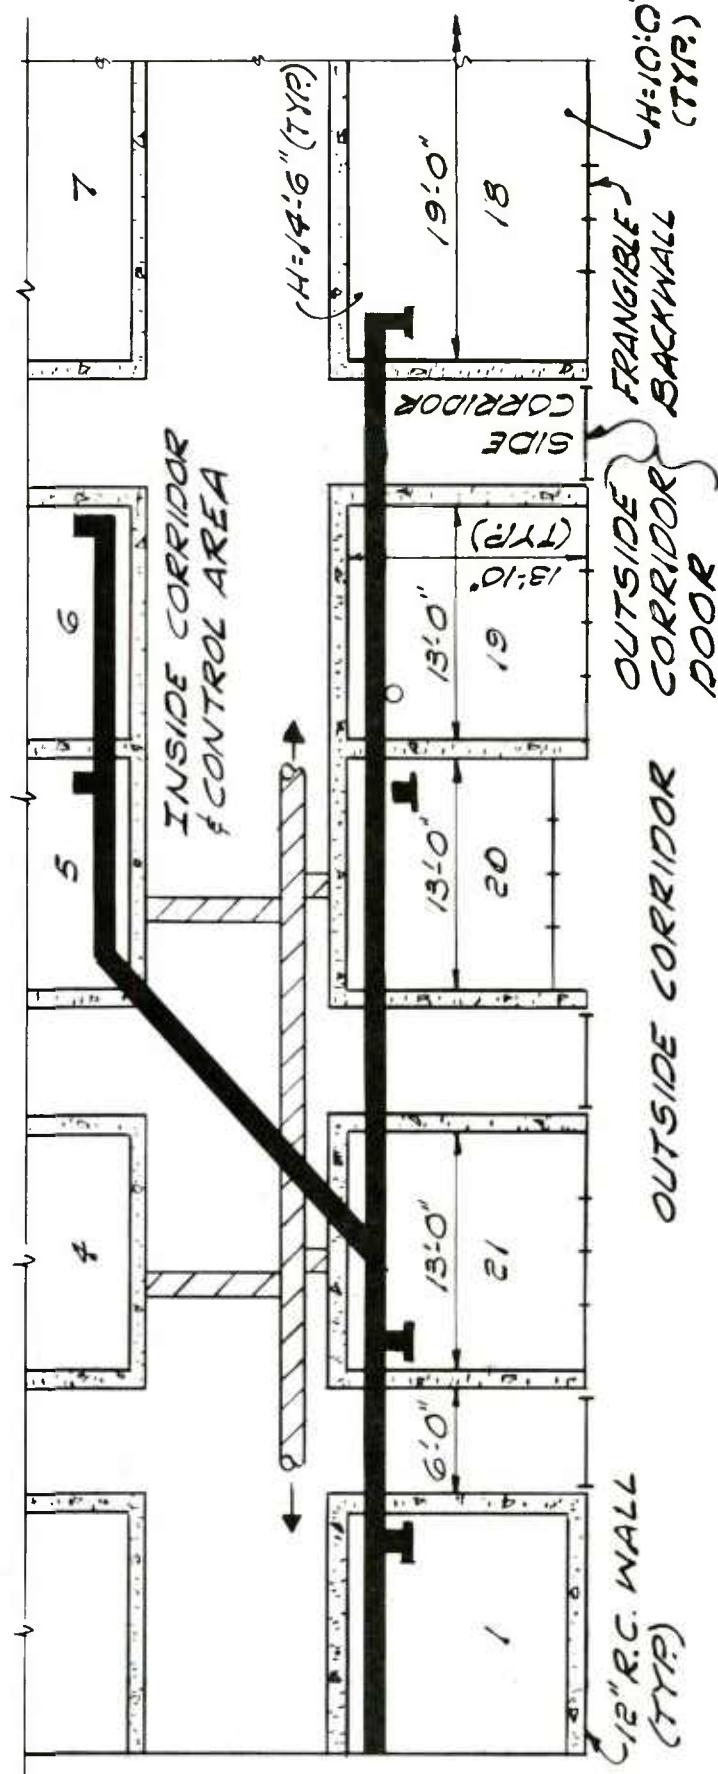
Avenues of direct propagation exist through the common acetone removal system and/or through the common heating system. Each bay is enclosed and provides no area of direct propagation either through an adjoining corridor or bay.

Figure 12 Partial Plan of Building 33-620 Pine Bluff Arsenal

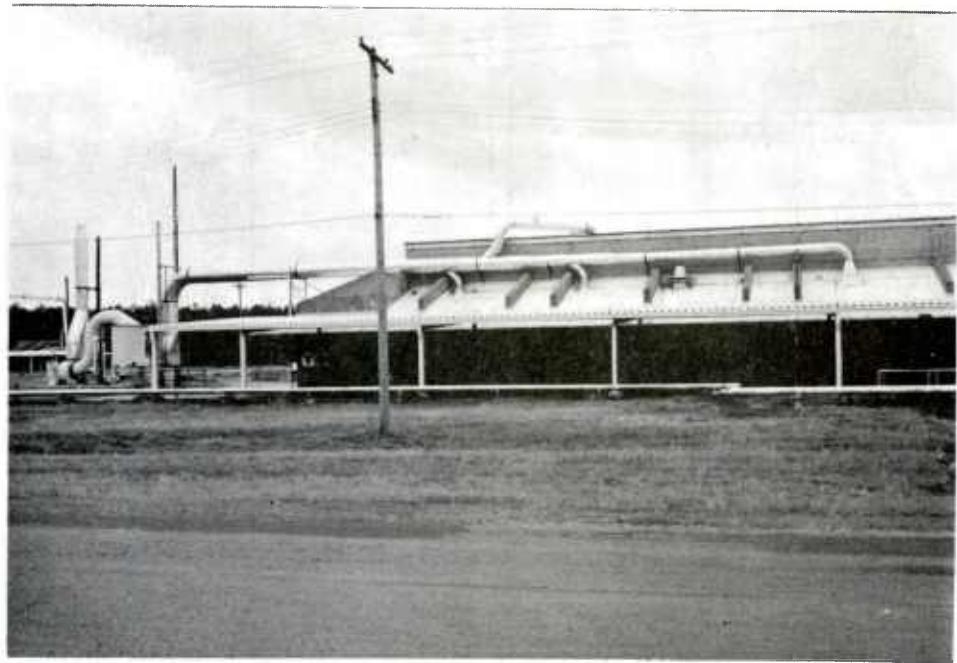
Figure 13 Common acetone removal system shown on bay roofs, Pine Bluff Arsenal

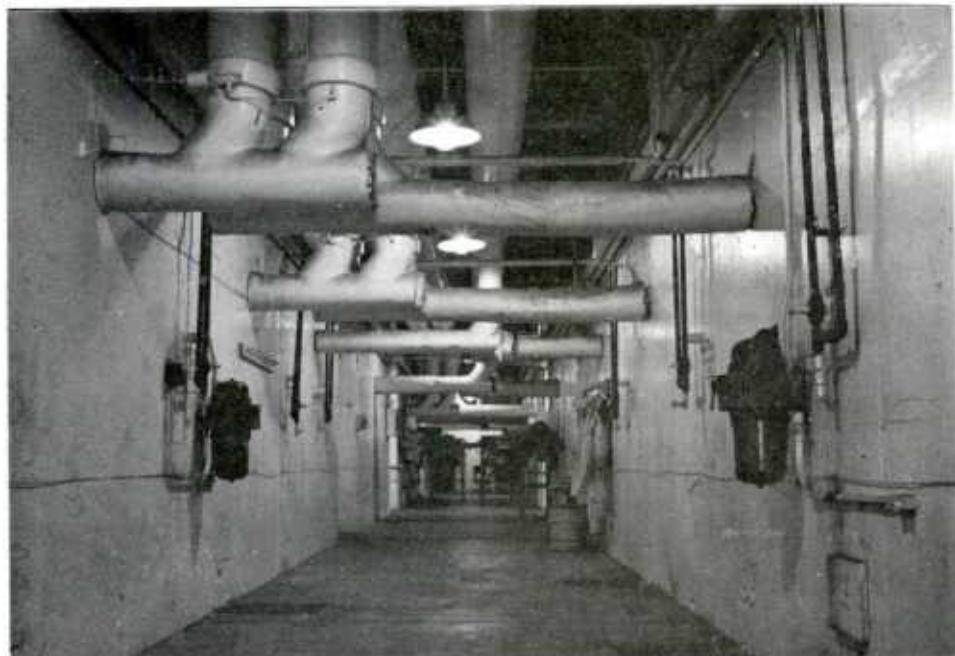
Propagation into the inside corridor due to blast pressures may occur through rupture of the heating system pipes or through the openings provided for the periscopes.

Figure 14 Common heating system joining each bay, Pine Bluff Arsenal

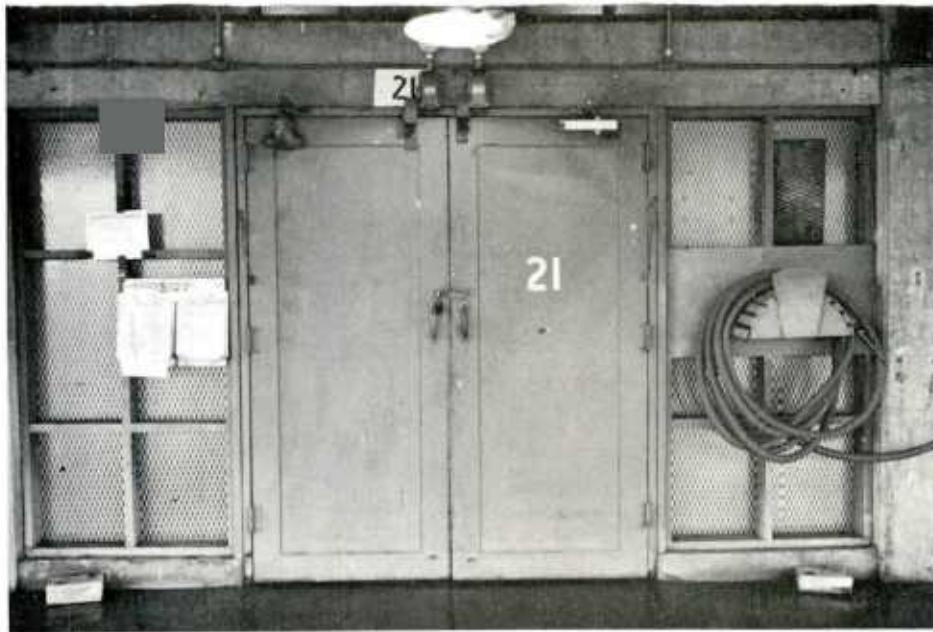
Figure 15 Frangible bay backwall, Pine Bluff Arsenal

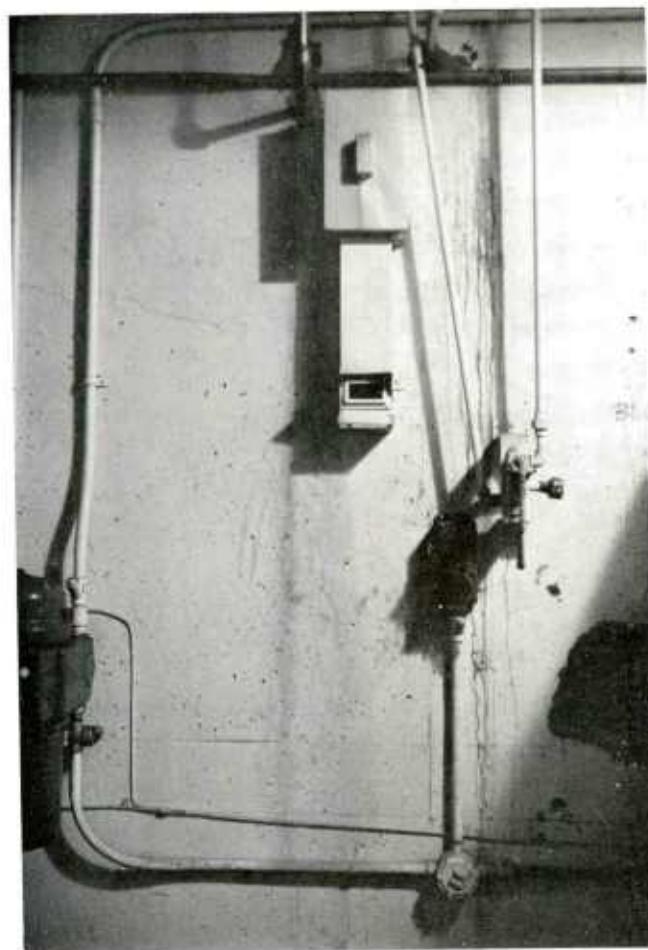
Figure 16 Bay frontwall periscope, Pine Bluff Arsenal

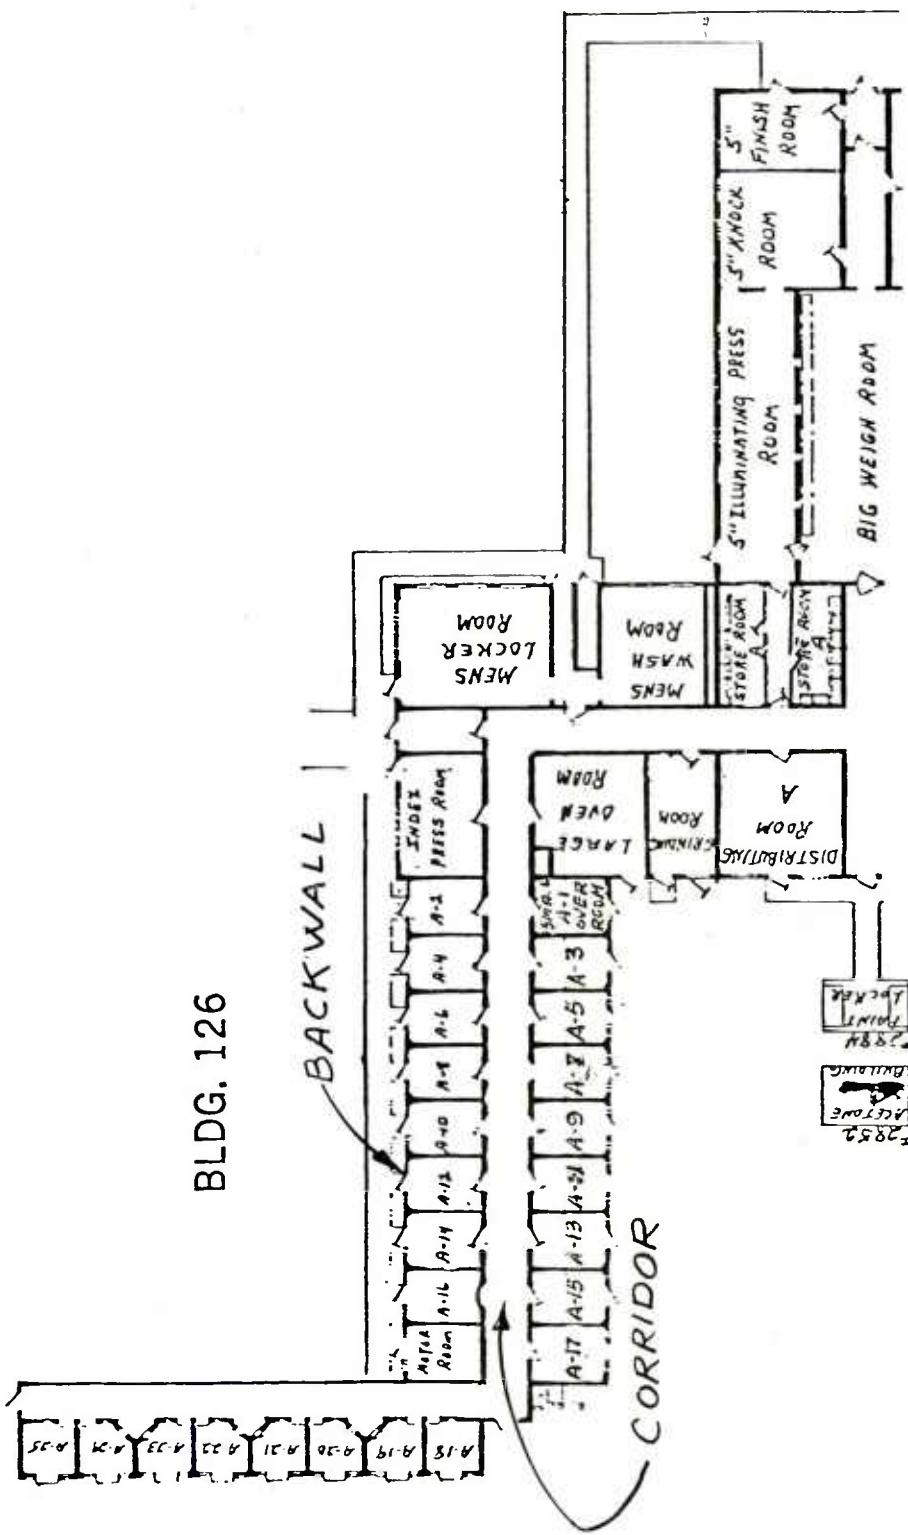
Propagation may occur through the heating and ventilating system which is interconnected under the corridor floor. Direct propagation is unlikely to occur from one bay to an adjacent bay since each bay is completely enclosed.

Figure 17 Plan of Bays of Building 126, Crane AAP

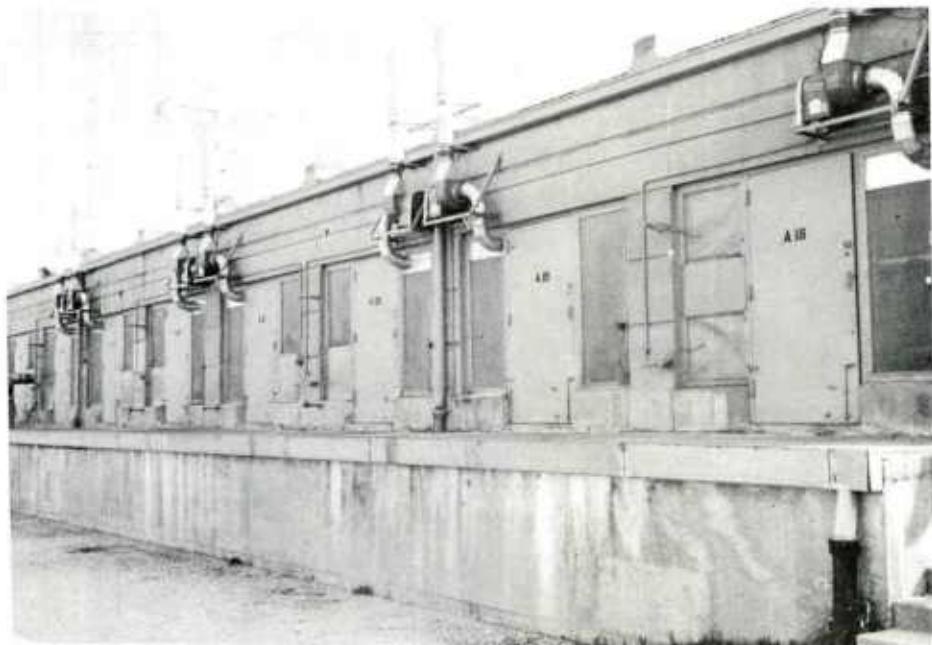
Figure 19 Individual acetone removal systems at each bay, Crane AAP

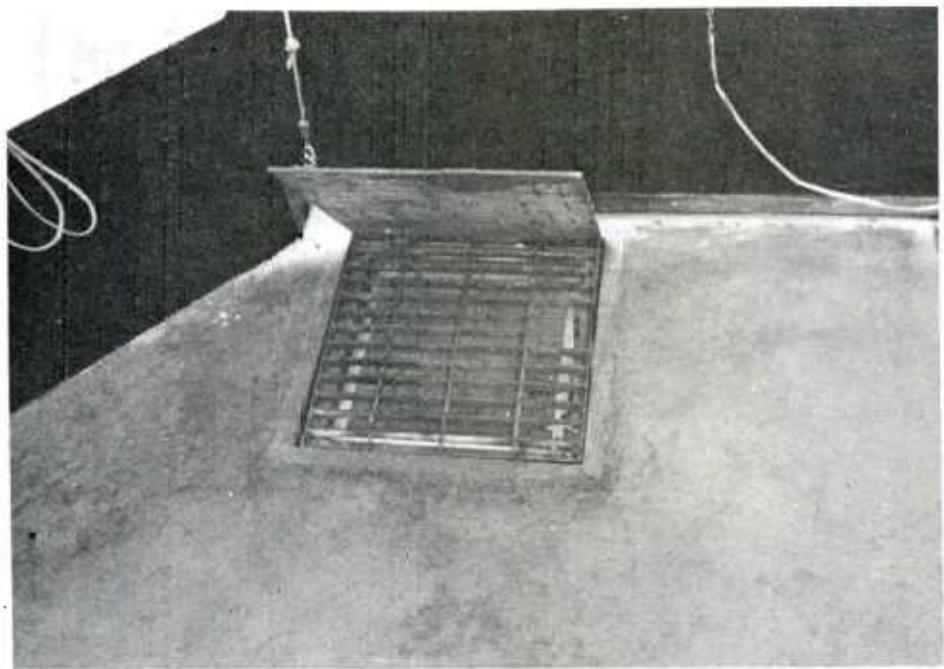
Figure 20 Floor mounted ventilating system, Crane AAP

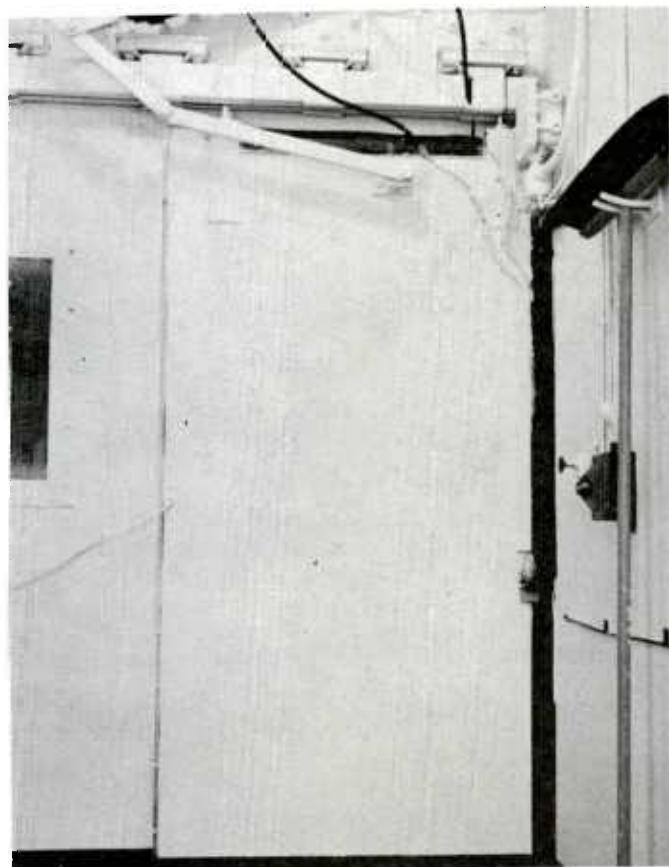
Direct propagation into the inside corridor can occur if blast pressures cause the interior corridor doors to fail. The aluminum plate doors offer minimal blast resistance. However, the sliding steel doors may offer some resistance. Failure of the viewing window either on the door or the frontwall can also lead to propagation due to blast pressures. If the doors or viewing areas are sufficiently strong to resist blast pressures, leakage may occur through the doors (which are not sealed) or through the viewports. Leakage will not usually cause propagation but a safety hazard may exist in the corridor at the door.

Figure 21 Sliding steel door on bay frontwall, Crane AAP

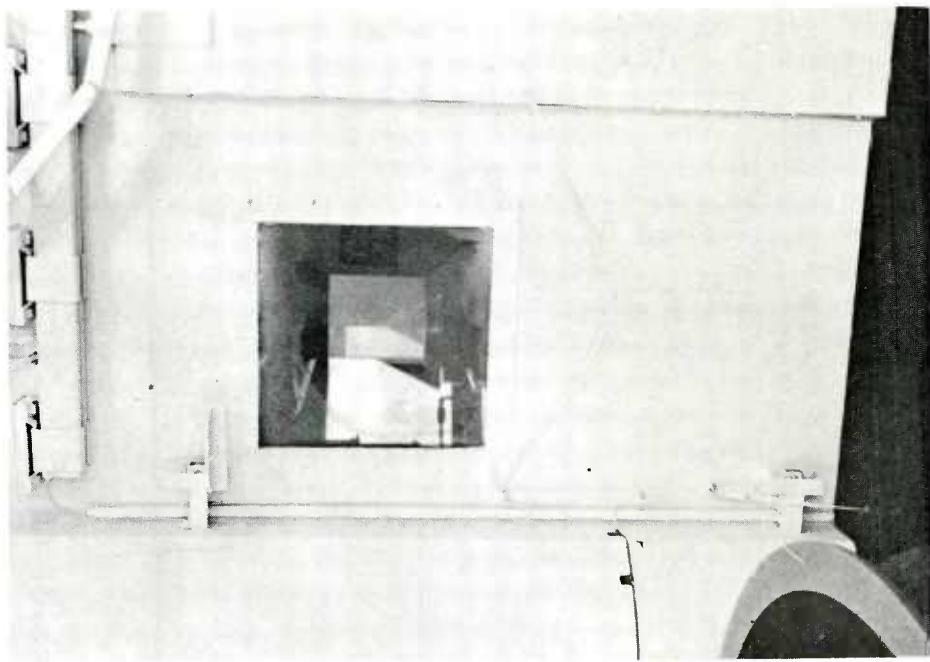
Figure 23 Window on frontwall of bay
Crane AAP

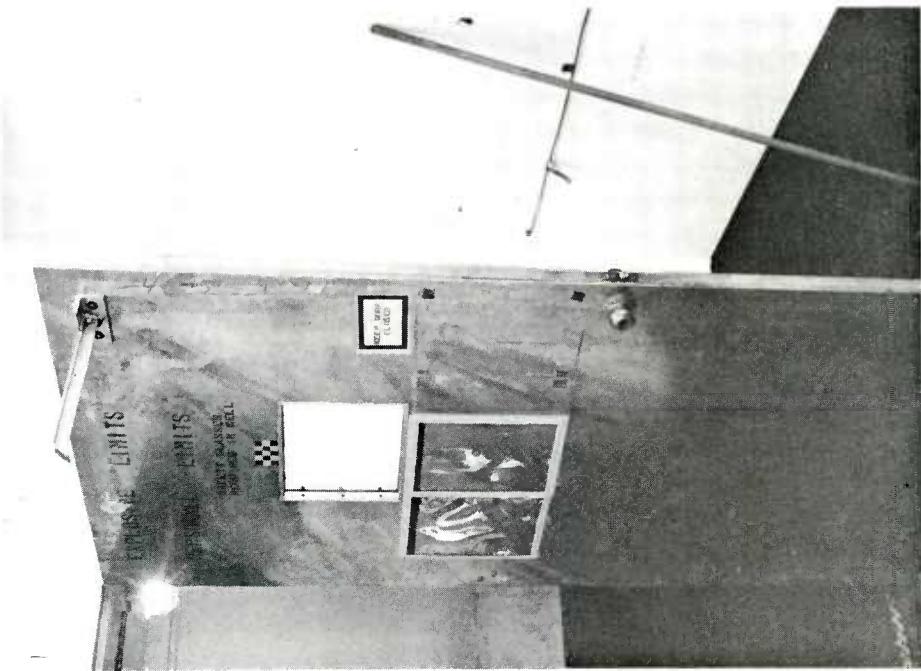
Figure 22 Aluminum plate bay door
with view panel, Crane AAP

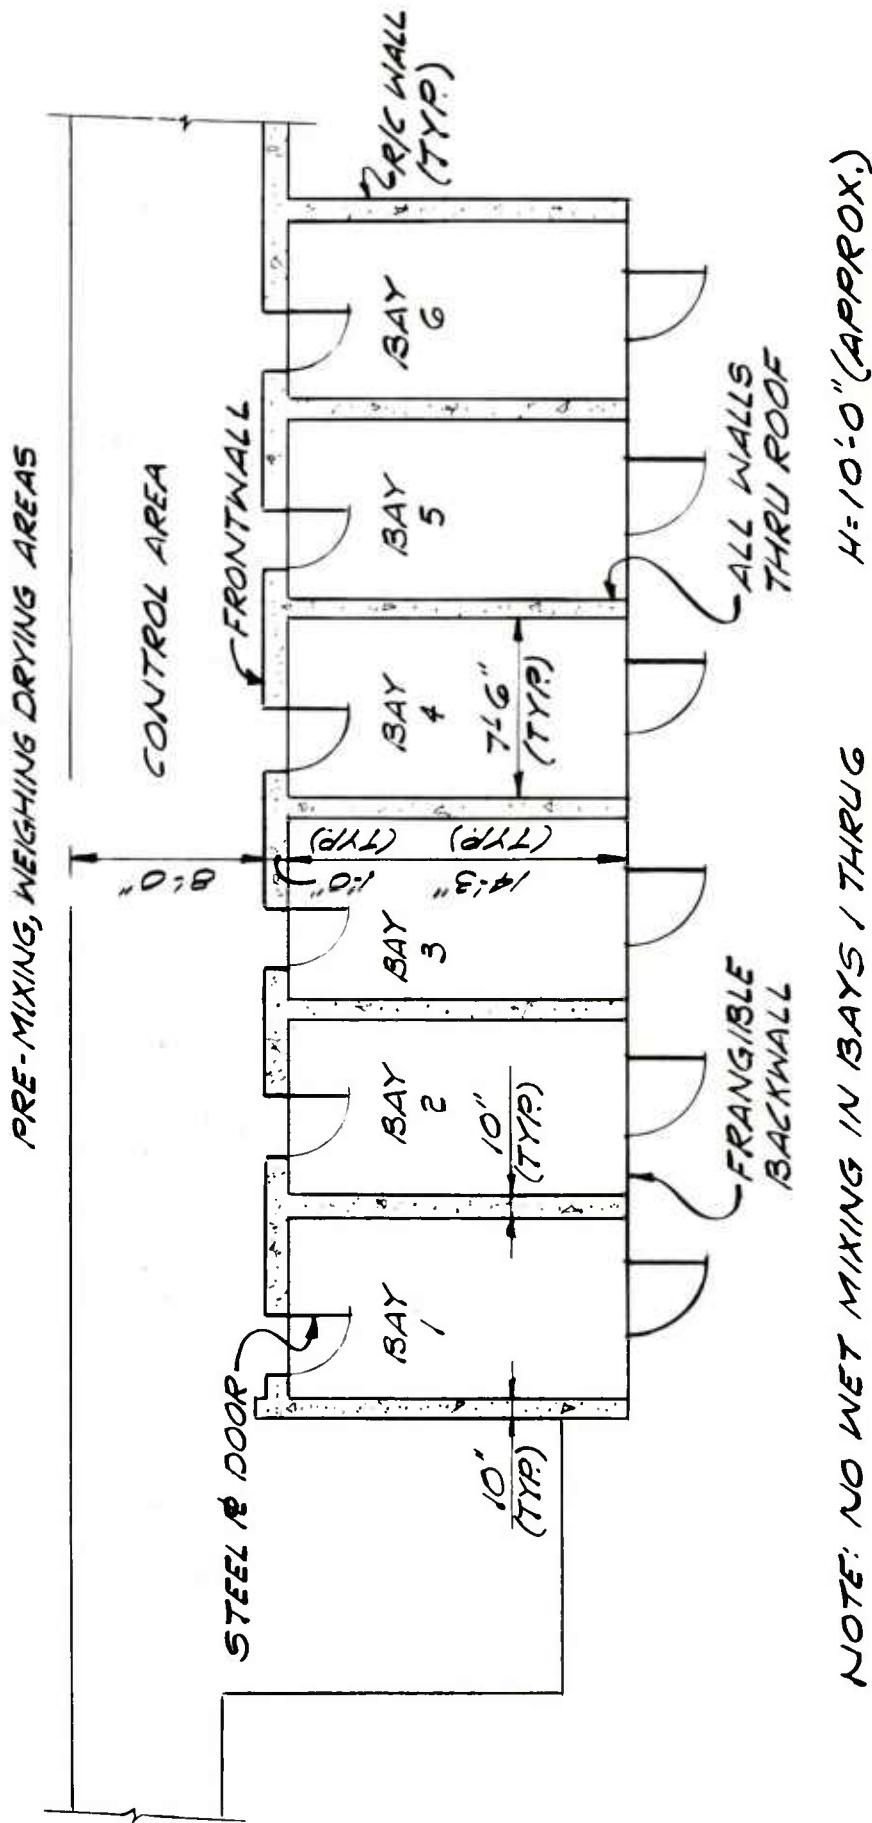
Propagation may occur in the form of a flame through improperly sealed doors. An approximate one-half inch gap exists below the steel plate door. Otherwise, each bay is entirely closed.

Figure 24 Partial Plan of Building 38A/B/C, Lake City AAP
